# Efficiency and Effectiveness of Sprinkler Systems in the United Kingdom: An Analysis from Fire Service Data

May 2017

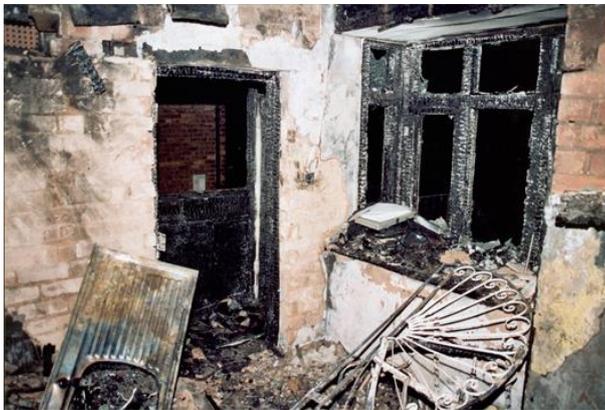
This fire in a seven-unit HMO in Birmingham was caused by an occupant not paying attention to cooking. It caused severe damage to the top floor flat and destroyed part of the roof. The heat and flames also caused damage along the corridors leading to the other flats. Although no occupants were injured in the blaze, the house was left uninhabitable throughout for a period of at least 6 months. The occupants had to relocate and the landlord lost rental income in addition to having to cover the repairs. No sprinklers were fitted in the premises

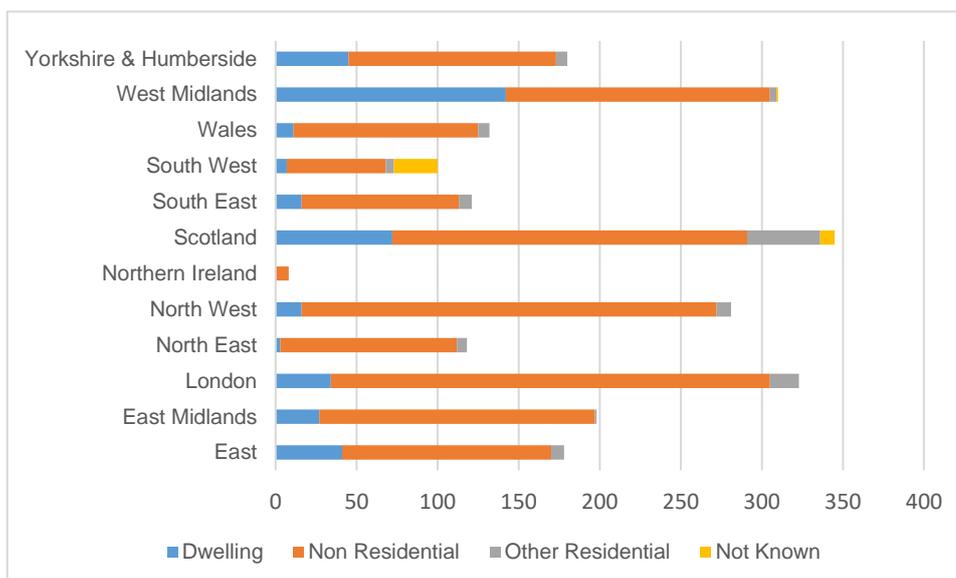
**Figure 3: Number of Fires with Sprinkler Systems by Building Type and Region**

- 2.1.3 The majority of the 2,294 fires with sprinkler systems (1,725 or 75%) were in non-residential buildings with a further 414 (18%) in dwellings (see Figure 2). Figure 3 shows the number of fires by building type and region. While all regions (except for Northern Ireland) had some dwelling fires, dwelling fires in the West Midlands accounted for almost 46% of fires. The position in the West Midlands is understood to reflect local authority policy regarding the use of sprinklers in social housing, particularly in communal bin areas.

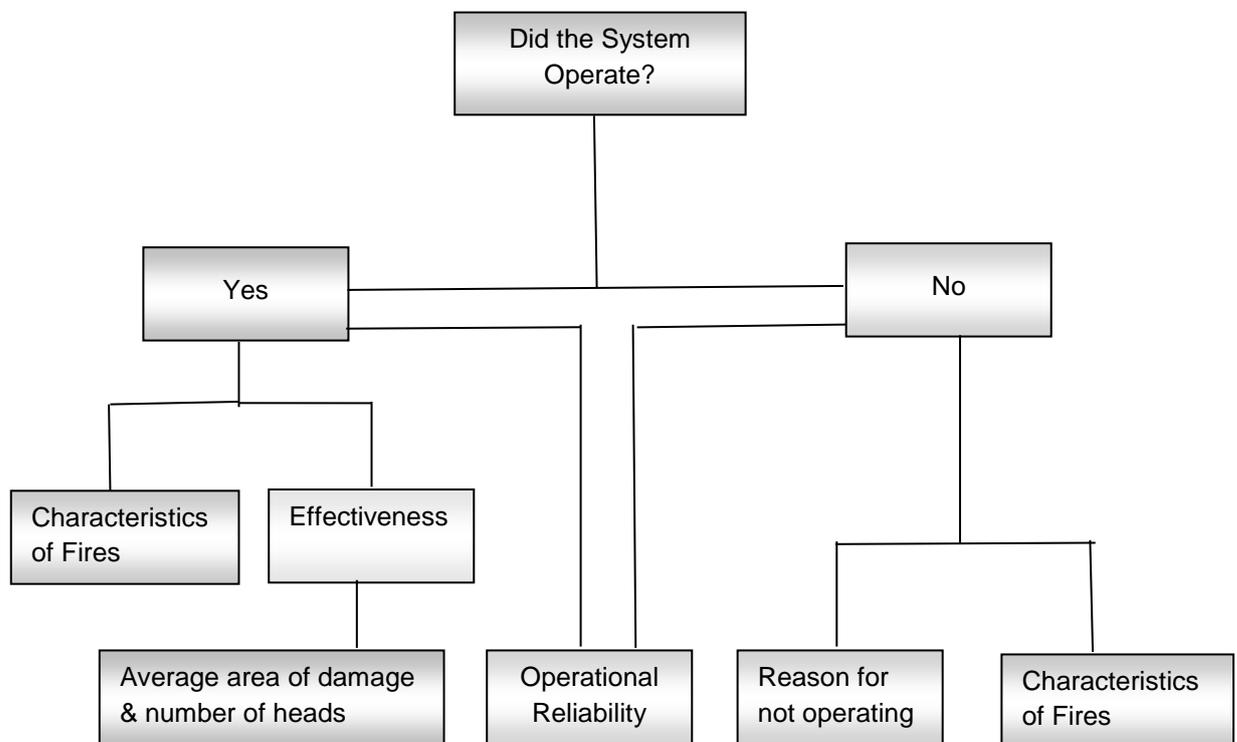
**Figure 4: Framework for Analysis**

2.2.3 The framework for the analysis is shown in Figure 4 and starts with the key question of whether the system operated. If the system did operate then the analysis establishes the characteristics of the fires e.g. where the fire was in relation to the sprinkler system (e.g. in the same room, on a different floor), how many heads activated and the extent of damage. The average area of damage and the average number heads activated are also estimated for those records where both the number of heads and area of damage has been provided. The impact of sprinklers on the fire (e.g. extinguished, contained/controlled) is analysed which enables the performance reliability or effectiveness of the system to be assessed.

- 2.2.4 If the sprinkler did not operate, the analysis considers the location of the fire in relation to the sprinklers and the reasons why the sprinkler did not operate. Where the system did not operate the analysis considers whether there are reasons that it could *not* be expected to operate e.g. because there was insufficient heat to activate the sprinkler heads. In assessing the operational reliability of the system the analysis takes account of circumstances where the sprinkler system could not be expected to operate.

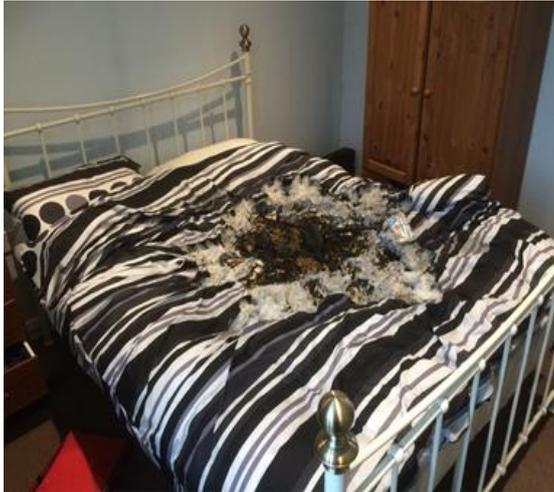
A fire occurred at a flat in a block of 26 flats in Suffolk. The vulnerable resident had been smoking in bed before going through to the kitchen where he had an epileptic fit. The bed caught fire due to smoking materials. Nearby residents were alerted by both smoke and sprinkler alarms.

A single sprinkler head operated and fully extinguished the fire. Fire Brigade personnel broke into the flat to gain access, finding the occupant unconscious in the kitchen following his seizure. The sprinkler system prevented the situation becoming much more serious and the resident was also able to return to the flat with minimal disruption.

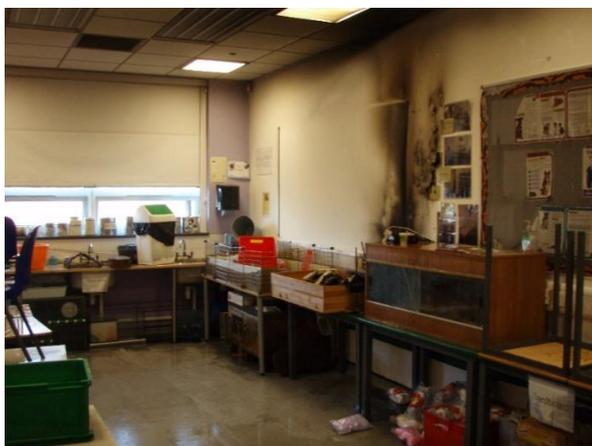
An electric heat lamp in the animal care classroom of a Newcastle school malfunctioned causing a fire with over 200 people on-site. One sprinkler head activated which confined the damage to the room of origin and extinguished the fire. A number of small animals were in the room involved and all survived whilst no other areas of the school were affected. Damage was limited to a wooden bench and minor smoke damage amounting to less than 1% of the whole building. Damage was repaired quickly.

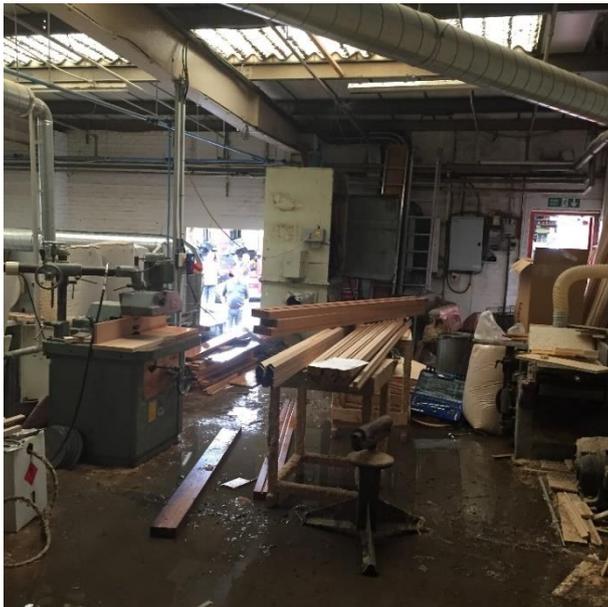
A fire was reported in a dust extraction unit at a joinery workshop in Nottingham.

The Fire Service found the fire was located inside the unit and that one sprinkler head above the unit had been activated. This had prevented the fire from spreading to other plant and materials. The unit was on fire internally and had badly smoke logged the workshop but, because the fire was contained, fire-fighters were able to extinguish it without too many problems

Fires in wood-working premises often take hold very quickly, resulting in extensive fire spread and damage. The sprinkler system had prevented this from happening.

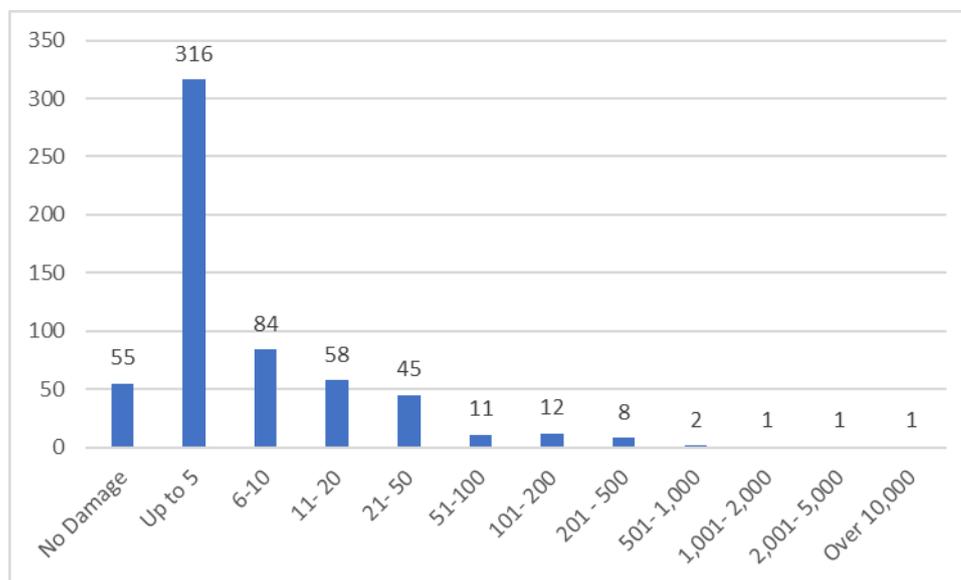
**Figure 7: Number of Fires by Area of Fire Damage (sq. m.)**

3.2.4 In terms of the area of fire damage, data are available for 594 fires where the system operated. The distribution of these fires by size of area damaged is shown in Figure 7. In the majority of fires where the sprinkler system operated there was a relatively small area of fire damage. Over 62% of the incidents had a fire damage area of up to 5 square metres (sq. m.) with a further 24% of fires having damage between 6 and 20 sq. m. Some 94% of fires where the area of damage is known had damage of less than 50 sq. m. There were no incidents in dwellings or other residential buildings which had an area of fire damage of over 100 sq. m. There was one fire where the area of damage was over 10,000 sq. m. and four fires with between 500 and 5,000 sq. m. of damage. All these fires were in non-residential buildings.

3.2.5 As a sprinkler system should provide sufficient water to control a fire, contact was made with the fire and rescue services reporting the very large fires to understand more about these cases. Further information was provided on three of the five very large fires:

- *Fire with over 10,000 sq. m. of damage:* This fire was in a factory manufacturing tissue paper. The manufacturing process produces a lot of paper fibres/lint which can accumulate around the building. In this case, there were sprinklers in the building, but the paper fibre/lint spread the fire. The dataset notes that only four sprinkler heads operated which is not consistent with damage of over 10,000 sq. m. as more sprinklers would be expected to open. It is possible that the recording of fire damage may not be accurate as there can be uncertainty between what constitutes fire and smoke damage.<sup>4</sup> It is concluded that the fire damage in this case was likely to be less than the 10,000 sq. m. reported and the damage area can be considered an overstatement.

- *Fire with 2,001-5,000 sq. m. of damage:* This fire was in a plant that handled and recycled plastic hangers comprising two adjoining buildings. The first building was gutted by the fire but the second remains intact. This fire started outside the buildings in a variety of externally stored combustible materials but, due to the nature of the materials, the fire spread. The external fire spread caused an explosion amongst liquid petroleum gas containers which spread the fire significantly to nearby vehicles, further stored goods and then into the factory. The sprinkler system in the factory operated at an early stage, but was overwhelmed by the explosion. The sprinkler system in the warehouse also operated and helped to save the warehouse.

- *Fire 501-1,000 sq. m.:* This fire was in a machine that spread to the roof frame and ducting which made the sprinklers less effective.
- 3.2.6 The additional information provided for the very large fires highlights that specific instances contributed to the large areas of damage reported. However, these fires are very rare, accounting for less than 1% of all fires where the system operated and the area of damage is known.

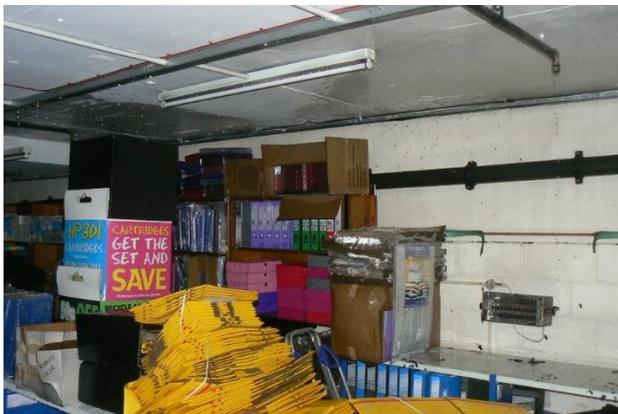
Fire-fighters were called to a shopping centre in Worcester after a fire broke out in the basement of a stationary shop where stock was stored.

There was a minimal amount of damage to stock from the fire and some water damage from the sprinklers. However, without the sprinklers operating, it is very doubtful that the shop would have been able to open for business on the day of the fire.

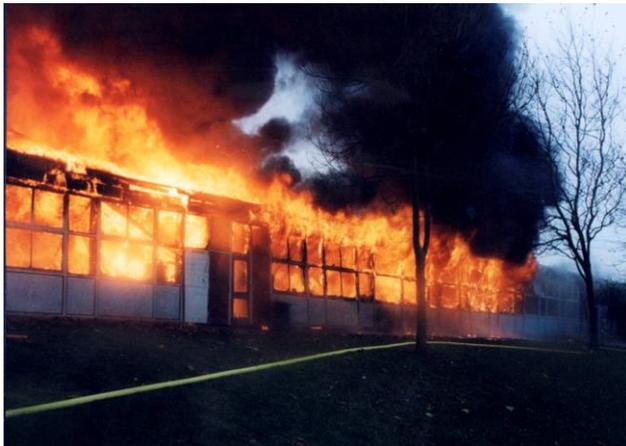
This fire occurred at a large high school in the West Midlands. The 1000 pupils were evacuated as fire spread rapidly through the science block. More than 100 fire-fighters attended the blaze which caused major damage and severe short term disruption to transport links. Pupils experienced long term disruption to their education, with many losing course work as a result of the fire. The damage was estimated to have been at least £15 million.

The school was rebuilt but the new school was not fitted with sprinklers.

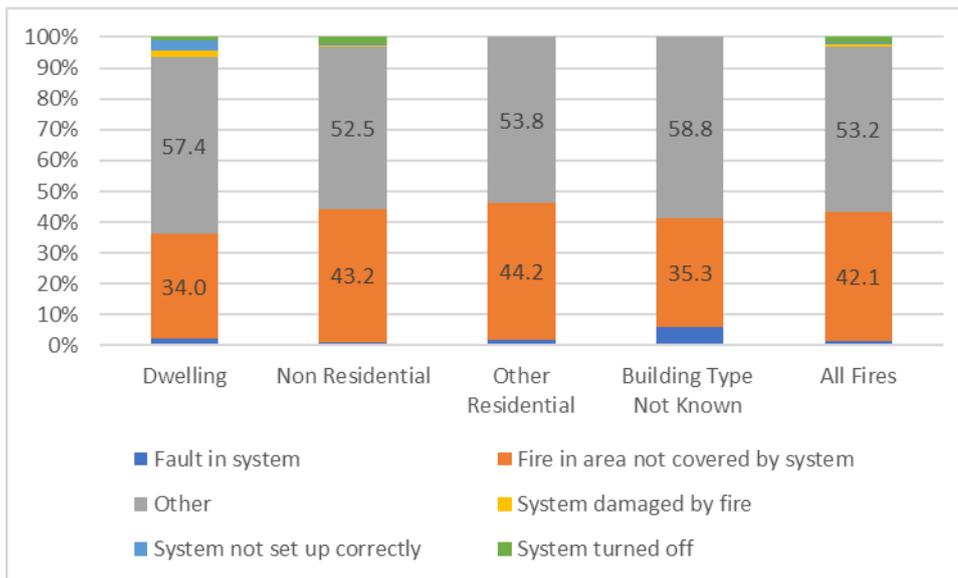
**Figure 10: Reasons why Sprinkler System did not Operate by Building Type, %**

3.3.3 Information on the reasons why the sprinkler system did not operate is available for 879 fires and these are shown in Figure 10. The reasons for the system not operating are dominated by two categories:

- Fault in the system – 12 incidents (1.4% of fires)
- System not set up properly – 4 incidents (0.5% of fires)
- System damaged by fire – 7 incidents (0.8% of fires)
- System turned off – 18 incidents (2% of fires).

- 3.3.5 Within the reporting system, there is scope to provide more information if “other” is given as the reason for the sprinkler system not operating. A total of 468 incidents (53% of fires) gave “other” as the reason for the system not operating and of these 145 provided further information which is shown in Table 5. Insufficient heat is the main reason for the system not operating.
- 3.3.6 Figure 11 shows the “other” reasons for the system not operating by building type. For dwellings and other residential buildings, insufficient heat was the only “other” reason cited for the system not operating.

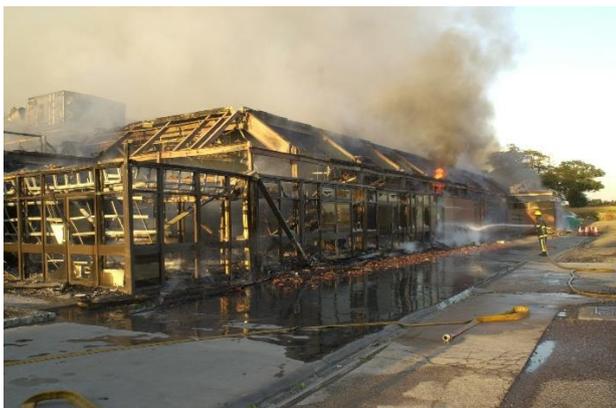
This fire destroyed large sections of the National Motorcycle Museum in Birmingham, along with hundreds of exhibits, including rare and vintage motorcycles. The fire is believed to have started outside the building and spread into the roof where it spread rapidly through the roof voids, destroying three of the five exhibition halls, along with their contents. Over 120 fire-fighters attended the fire with poor water supplies at the site proving disadvantageous. The complex was rebuilt with sprinkler protection included and slowly the collection has been rebuilt or replaced.

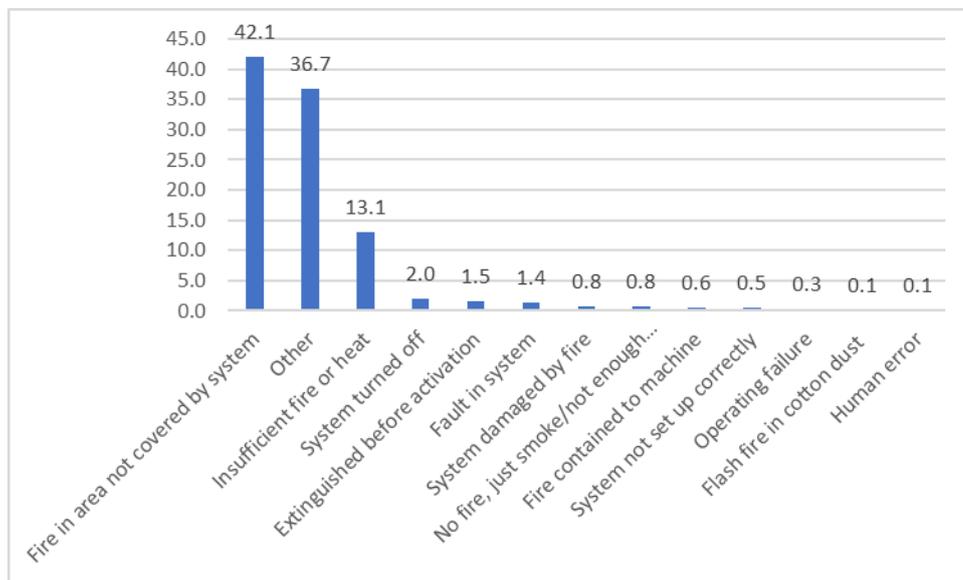
**Figure 12: Distribution of Reasons for Sprinkler not Operating, %**

3.3.8 Hence, in 58% of cases where the system did not operate, it was because it could not be expected to operate, primarily because the fire was in an area not covered by the system or there was insufficient fire or heat. Known cases of system failure are very rare with a fault in the system occurring in 12 cases (1.4% of fires) and operating failure occurring in three cases (0.3%) of fires. In 18 cases (2% of fires), the system was turned off. No further information is available to determine if the system was turned off or decommissioned. If decommissioned, the system could not have been expected to operate and would not be classified as a system failure. However, in the absence of additional information we have assumed that all fires where the system was turned off are system failures.

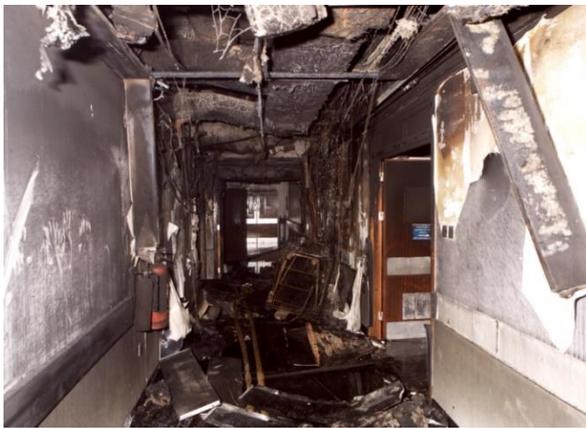
A fire broke out in the A&E department of Sandwell and District Hospital in West Bromwich with the fire and smoke spreading rapidly and large sections of the hospital evacuated, including operating theatres which were in use at the time. Some patients were transported in emergency vehicles so that their treatment could continue at other hospitals nearby. The fire was particularly severe and caused £11 million of damage. The A&E was completely rebuilt at a cost of £18m. As a result of the lessons learned from the fire, sprinkler provision was provided as part of the rebuild programme.

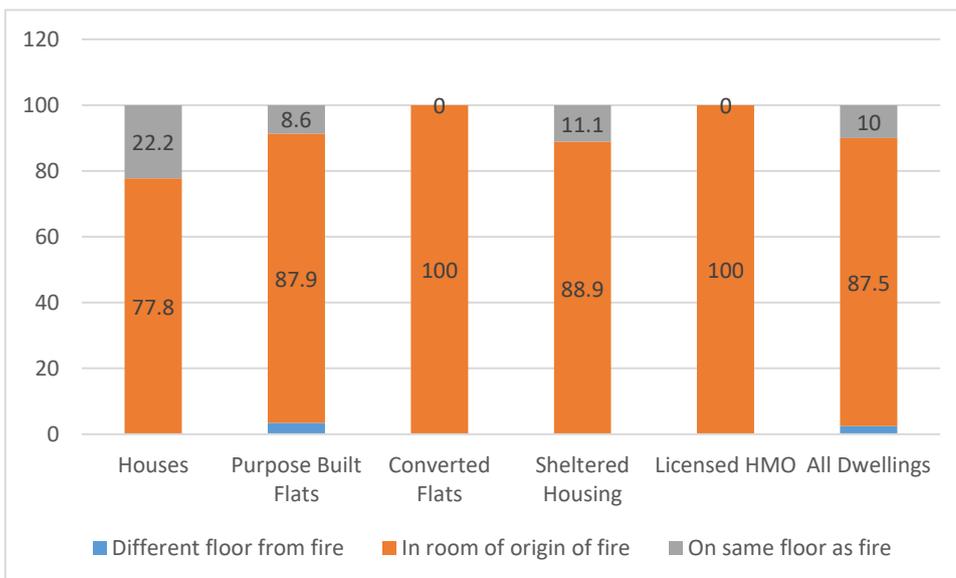
**Figure B3: Location of Sprinkler System where System Operated by Dwelling Type, %**

Of the 414 dwelling fires, the system operated in 276 instances. However, data are limited on the location of the system to 80 fires. Figure B3 shows the location of the system in relation to the fire for these cases. Across all fires where the sprinkler operated, the sprinkler was in the room of origin of the fire in 88% of cases.

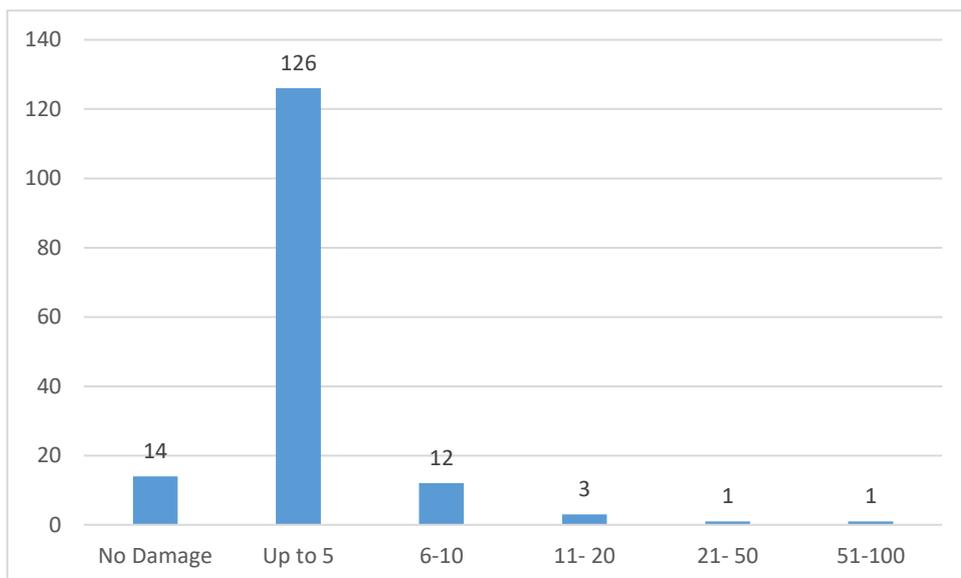
**Figure B5: Number of Dwelling Fires by Area of Fire Damage, sq. m.**

In terms of the area of fire damage where the sprinklers operated, data are available for 157 of the 276 fires. The number of fires by area is shown in Figure B5. Some 89% of fires had less than 5 sq. m. of fire damage.

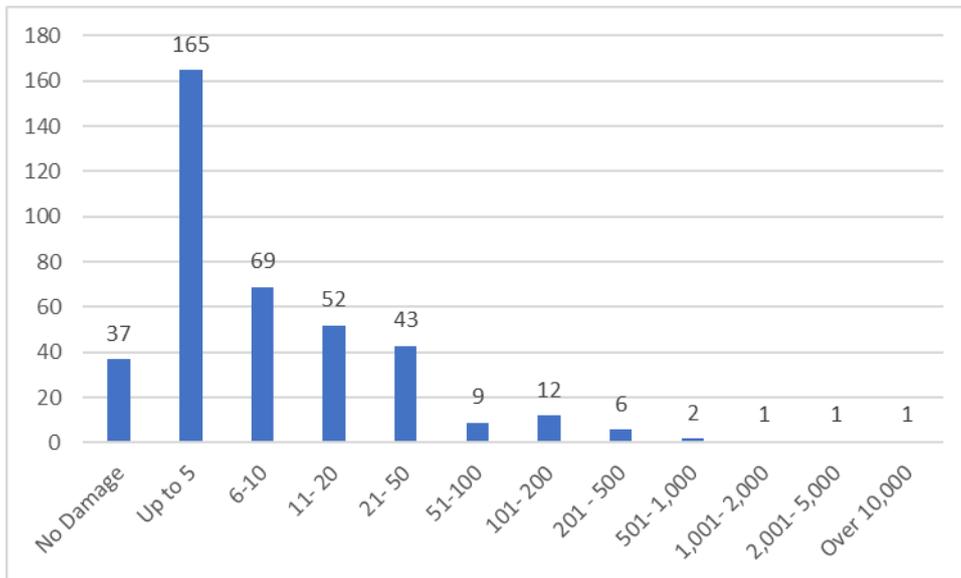
**Figure B13: Number of Non-Residential Fires by Area of Fire Damage, sq. m.**

In terms of the area of fire damage where the sprinklers operated, data are available for 398 fires and the number of cases by area of fire damage is shown in Figure B13. Some 68% of fires had less than 10 sq. m. of fire damage.
